**BALD HEAD ISLAND, NC
SAND SHARING SYSTEM
OVERVIEW AND ASSESSMENT**

**Erik J. Olsen, P.E.
Olsen Associates, Inc.**

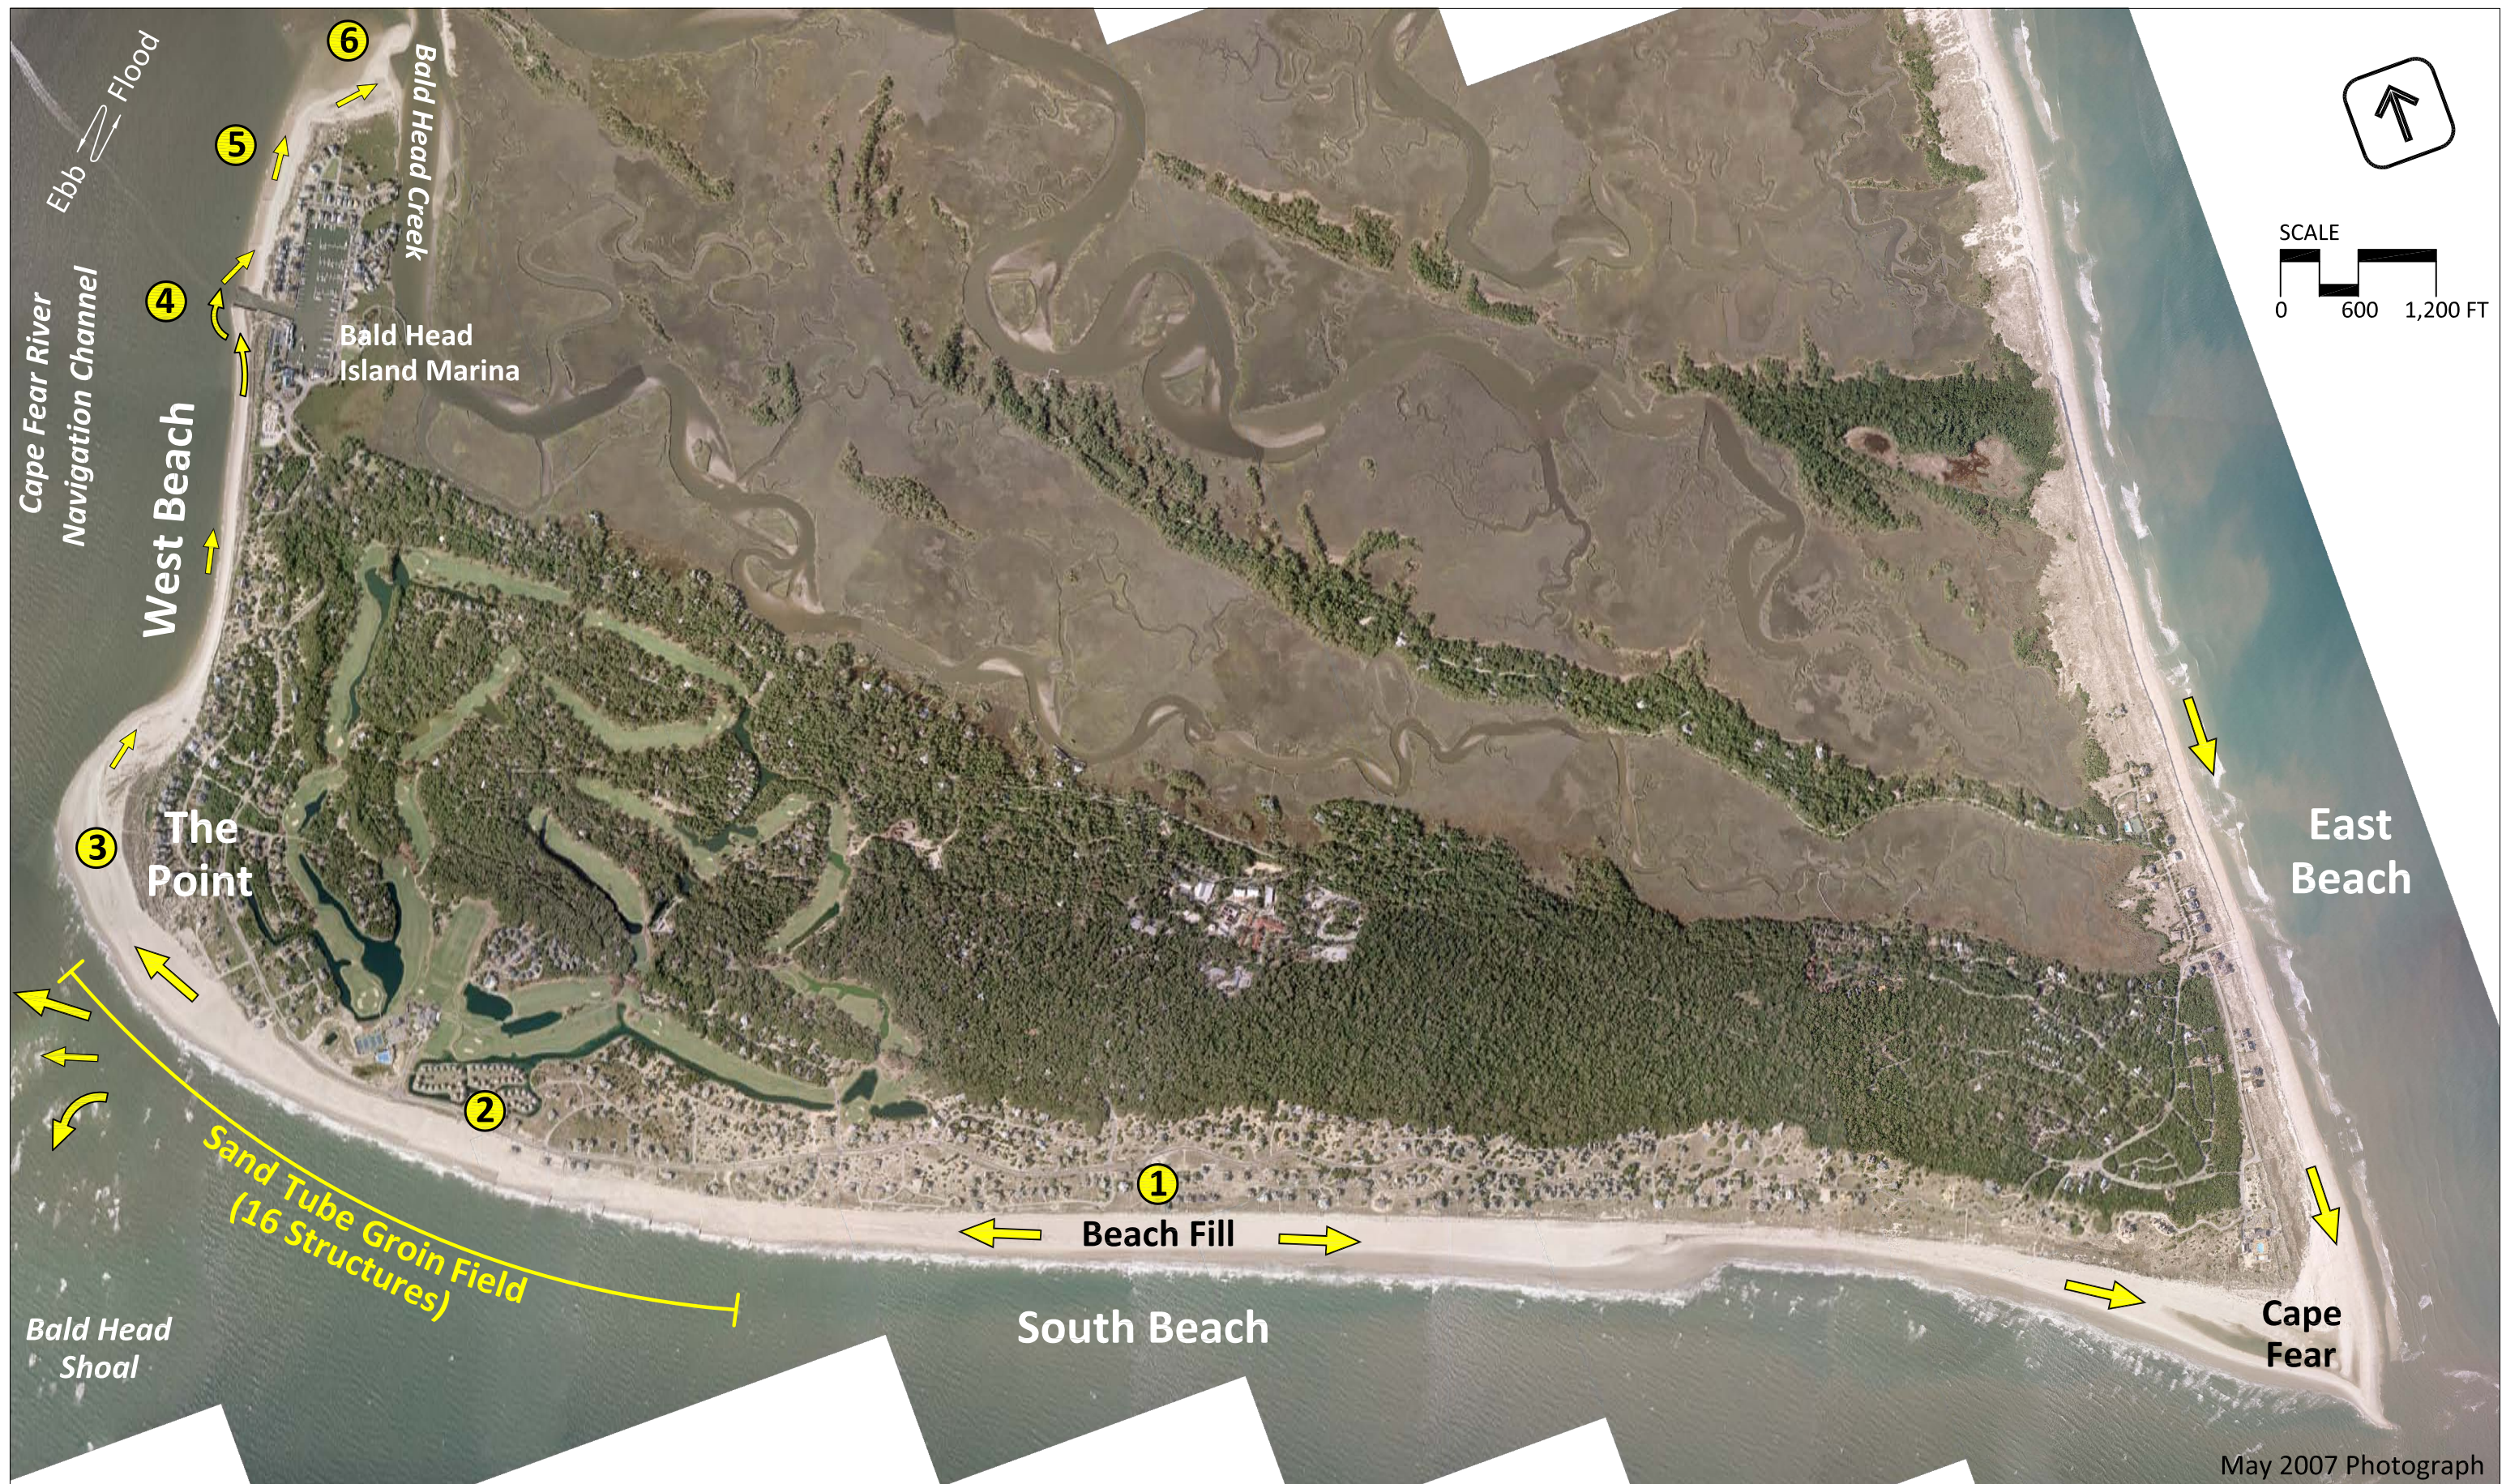
Figure 1: Sediment Transport Trends.

The following discussion is a simplistic overview of the existing natural and man-induced sand sharing system which presently exists at Bald Head Island. Figure 1 is a photo-based schematic which provides an islandwide perspective and definition of the various shorefront features to be addressed herein.

East Beach – Net littoral transport along the East Beach side of Bald Head Island is strongly from North to South. Virtually all sediment transported southerly ultimately resides in the Cape Fear depositional feature or the expansive Cape Fear shoal system which extends to sea for several miles southward thereof.

South Beach (1) – Net littoral transport along South Beach is bi-directional. That is to say, there is an effective nodal point in the centermost one third of the island. To the east of the nodal point *net* transport is easterly to Cape Fear. Westward of the node, *net* transport is westerly toward the river. Along the westernmost segment of South Beach is a 16 sand tube groinfield (2) intended to reduce the rate of transport toward the Point and federal navigation channel. The principal benefit of the groinfield is to greatly reduce the landward migration (or extent) of the Mean High Water (*i.e.*, MHWL). The groinfield is most effective when there is a significant volume of sand within the sand sharing system of South Beach resulting from sand placement (*i.e.*, beach disposal or nourishment). Since 2001, some 3.9 Mcy of sand have been placed along South Beach as a direct result of beach disposal activities performed by the Wilmington District USACOE in accordance with the Wilmington Harbor Sand Management Plan. It is the intent of the VBHI to construct a separate and distinct beach fill project along South Beach in the winter of 09/10.

The Point (3) – Sediment that moves westward from either beach fill or beach disposal projects through the groinfield is transported either to the Point (in the form of temporary accretion) or to the inlet gorge (and navigation channel) as well as the nearshore portions of Bald Head Shoal. The Point itself is an accretional feature whose size and configuration are the result of an ever changing balance among factors which include: sediment removed by dredging, littoral sediment driven to the Point along South Beach and tidal/riverine currents which remove sediment by erosion (both to the offshore shoals and the Cape Fear River gorge). Any major changes in this “balance” of forces, including super elevated periods of wave energy resulting from major storms will reshape the footprint of Point. The VBHI beach monitoring program has relatively well documented adverse effects directly related to the dredging of the toe of the Point which extends into the defined limits of the federal navigation channel. Such dredging events typically occur on a 24-month basis.

Marina Entrance (4) – In order to stabilize the entrance to the Bald Head Island marina, two (2) stabilizing structures extend from the upland basin into the Cape Fear River. On the West Beach updrift side of the entrance, the current low water shoreline is at the westward end of the south jetty structure. As a result, some percentage of the littoral sediment naturally transported to the jetty is easily driven around it and into the marina entrance channel. As a result, frequent maintenance dredging is performed by Ltd. By permit, Ltd. is allowed to not only dredge the marina entrance channel footprint but also to perform advance maintenance in a southerly direction so as to allow for a certain amount of advance shoaling to occur prior to its introduction into the channel per se. All material excavated by dredge is “bypassed” to the north shoreline so as to alleviate downdrift erosion on the Row Boat Row shorefront caused by the two (2) entrance channel jetties. Since, the south entrance jetty is currently overwhelmed by sand, it is now certain that all material transported to the jetty is either diverted to the Cape Fear River channel, or maintenance dredged during shoal removal operations. Such jetty structures are highly effective in directing sand seaward to the Cape Fear River channel due to the diversion of water and sand during high energy storm conditions. To break up or disrupt the “efficiencies” of this sand loss phenomenon, a spur is often added to the side of such a shore perpendicular structure.

Bald Head Creek (6) – Again, as a direct result of continued high frequency sand bypassing at the marina entrance, the sandy shorefront eastward of the northernmost timber groin, has been highly depositional and as a result has seen substantial growth over the last 20-30 years. Additionally, sand now migrates into the mouth of Bald Head Creek in the form of a depositional spit. Although approximately 45,000 cy of sand were removed from this shoal in 2005 (and back-passed to West Beach), the shoal rapidly reformed. Without a dredging protocol and a terminal structure at the mouth of Bald Head Creek, shoaling conditions will remain relatively unchanged into the future. As shown by Figures 1 and 2, the entrance to Bald Head Creek is the effective terminus of the sand sharing system of interest. Northward of the Creek, sand lost from the Creek shorefront or spit formation moves off to the submerged shoals located northward thereof. Portions of the shoals are exposed at low tide. Limited navigational access (small boats only) in or out of Bald Head Creek is therefore limited to high tide and fair weather conditions.

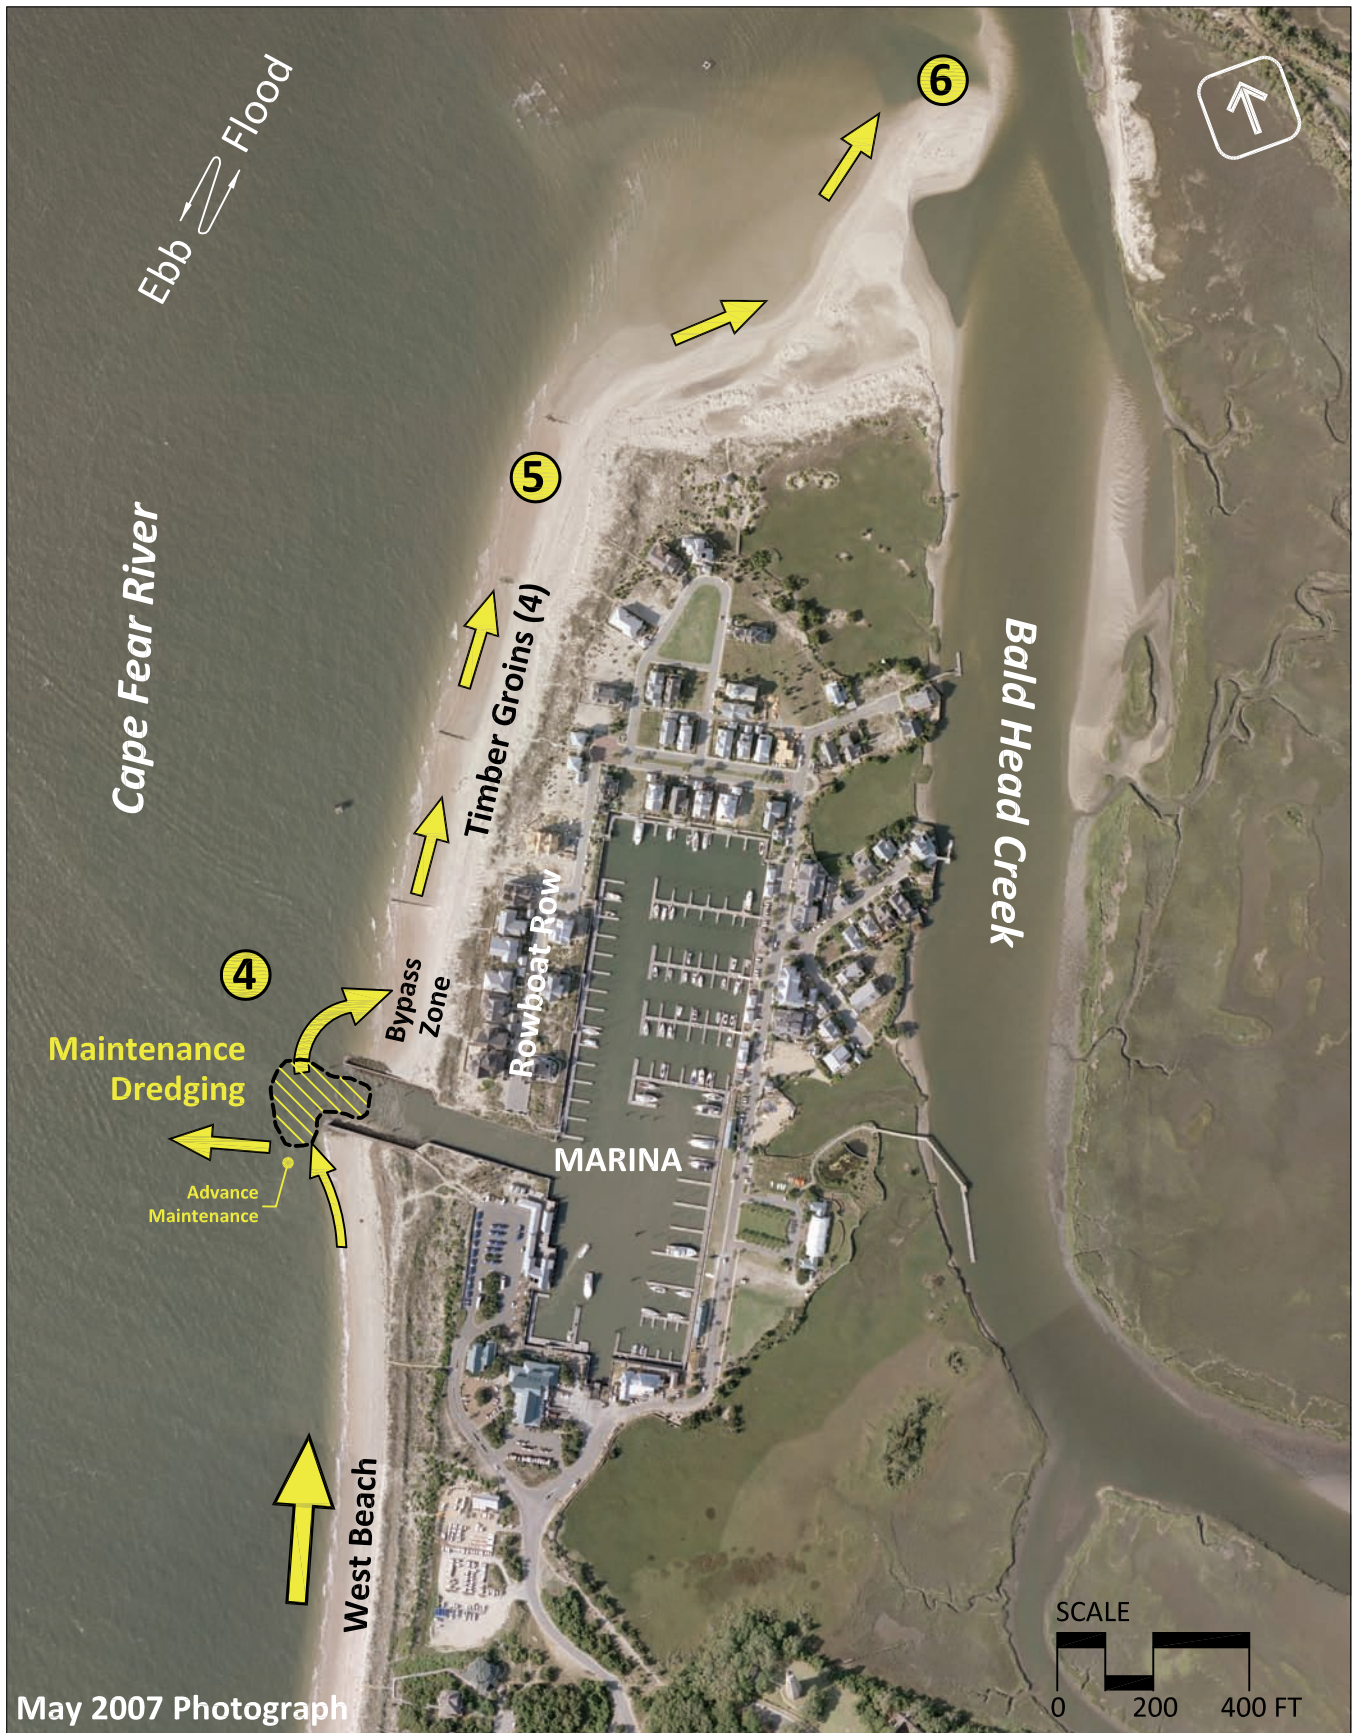
Figure 2: Sediment transport bypass trends at the marina entrance (West Beach).

Timber Groinfield (5) – On the downdrift (*i.e.*, north) side of the marina entrance there is a timber groinfield intended to improve the longevity of bypass sand placed at that location (see Figure 2). The groins are presently in a deteriorated condition and subject to major reconstruction. Regardless of the groins condition and the fact that their spacing is less than optimum, the groinfield has been successful in maintaining a beach/dune system seaward of the seawall which lies upland of this shorefront strand. The principal reason for the successful ongoing stabilized shorefront at this location is the high frequency sand bypass operation resulting from marina entrance channel maintenance. At present however, the MLW line extends to the end of the north entrance channel jetty, thereby facilitating the return of sand to the marina entrance. The location of bypass sand in relatively close proximity to the marina entrance likewise contributing to sand entrainment back into the marina channel.

Timber Groinfield – The VBHI has recently received cost estimates for the major rehabilitation of the existing four (4) structure groinfield located northward of the marina entrance. Alternate quotes provide for the replacement of timber sheeting with vinyl sheet piling to reduce future maintenance. Similarly, each structure should have the rock replaced at its head *with* the addition of an appropriate geotextile composite type underlayment intended to reduce rapid subsidence of the stone. Groin rehabilitation is considered to be a high priority action item of significant public interest.

Timber Groinfield – It is presently recommended, that as structural measures go, the rehabilitation of the groinfield should be given highest priority. It is clearly necessary even if dredging and sand disposal frequencies remain unchanged. Minimal repairs to the groins will serve little useful purpose. Moreover, when the structures are reconstructed or replaced, it is very important that the stone armoring at the head of each groin is replaced with a suitable foundation to both reduce subsidence and enhance stability of the exposed terminus of each structure under storm conditions.
