Executive Summary of the Sand Management Plan and 2005 Agreement

July 29, 2011

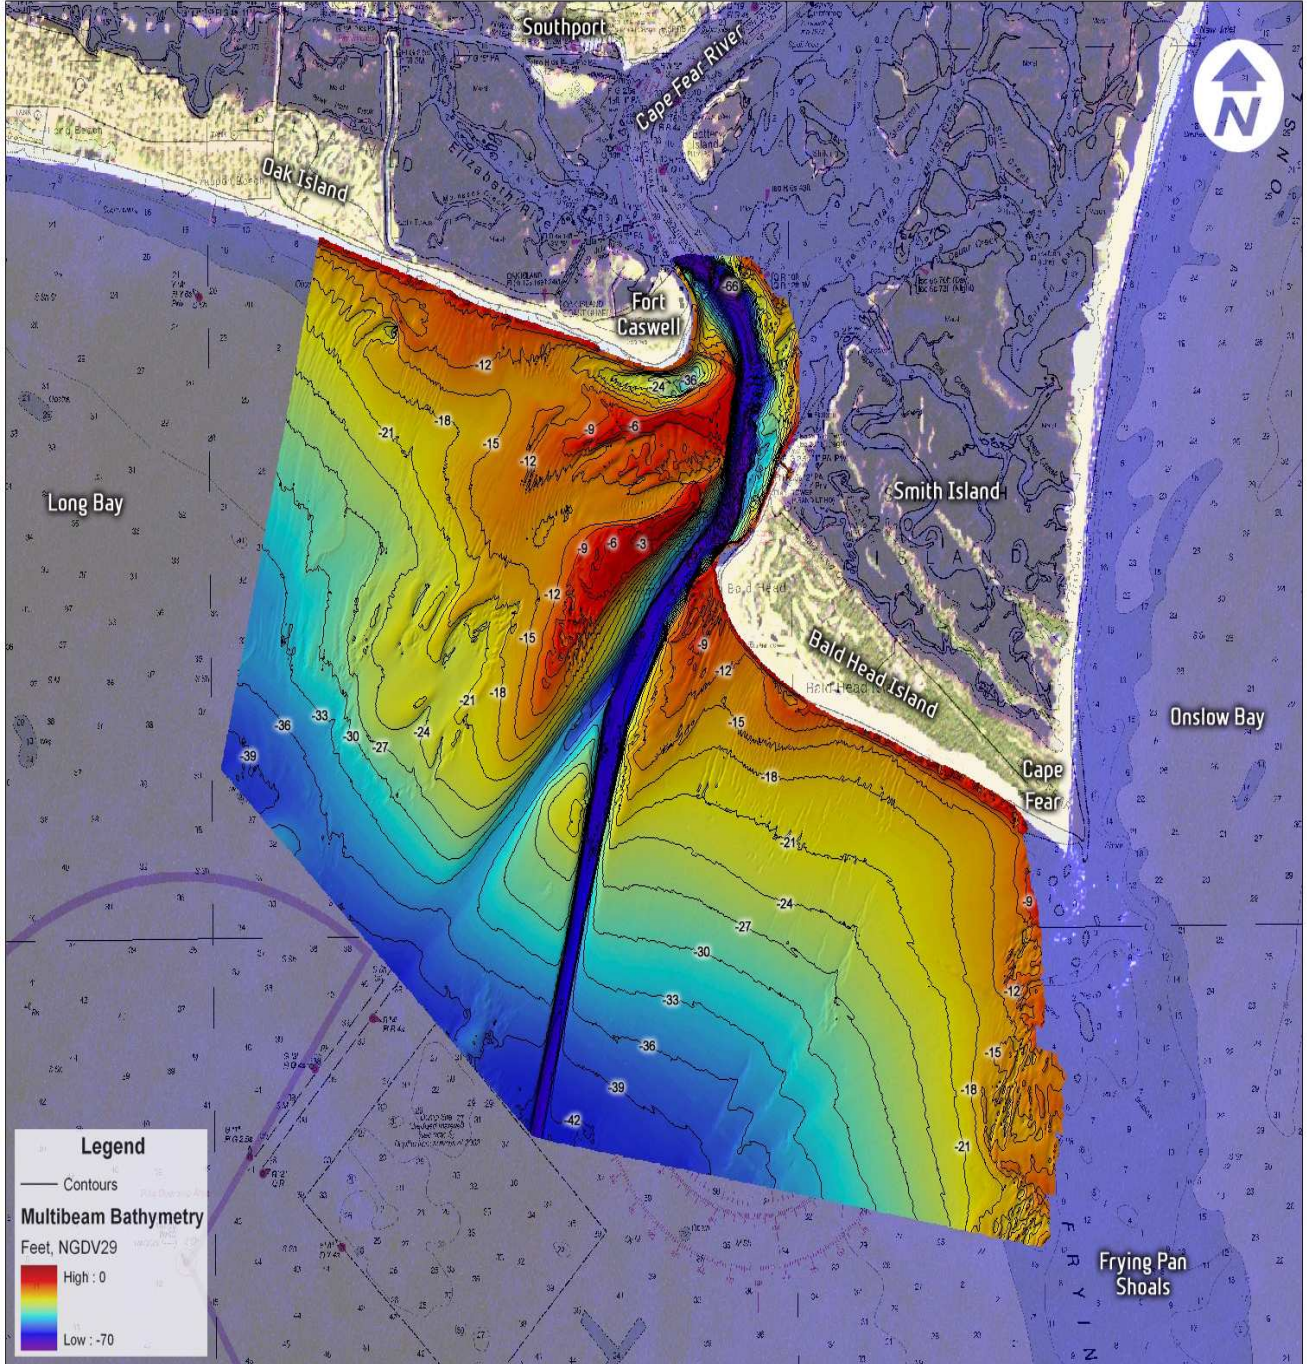
The following bathymetry survey (measurements of the depths of oceans, seas, or other large bodies of water) conducted on behalf of the Village shows the location of the channel prior to its relocation.

The deepening of the channel from approx. 38' to 42' plus a 2' overdraft was to accommodate larger ships in the transport of goods to the Port of Wilmington. The realignment of the ocean entrance channel was not part of the initial 1996 project feasibility report. A Value Engineering Study conducted after the feasibility report, recommended moving the channel to significantly reduce construction costs by avoiding rock in the existing channel. The realignment swung the entrance channel closer to the Point of Bald Head's West and South beaches.
