The Village of Bald Head Island

MEMORANDUM

Re: Weekly Status for 15 - 19 DEC 2008

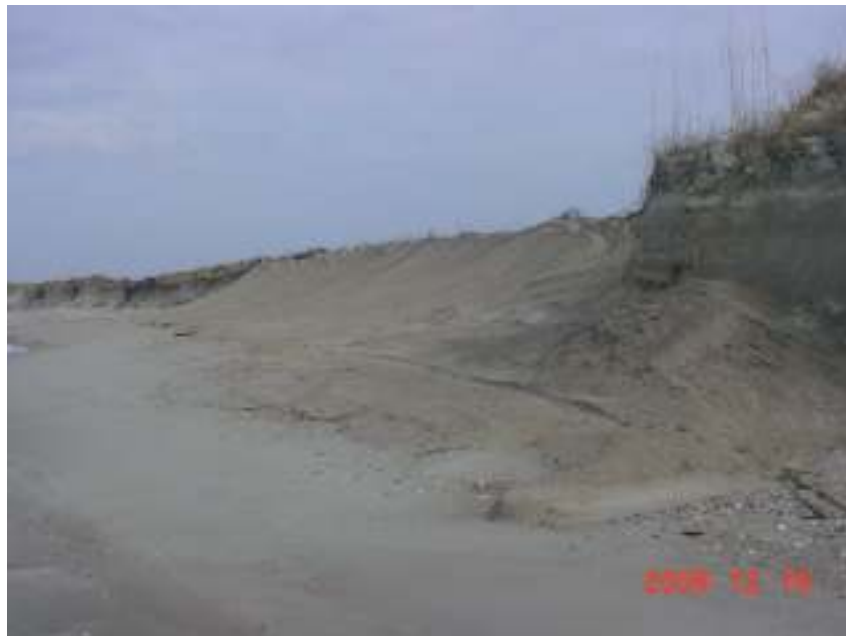
West Beach Sand Push – Island Contracting has started the emergency sand push on the southern end of Cape Fear Trail and will push approximately 650' linear feet from 9 Cape Fear Trail to 17 Cape Fear Trail. In addition, sand will be pushed on west beach from 35 Cape Fear Trail to 21 Sea Gull Trail approximately 1,300' linear feet (See attached .jpeg).

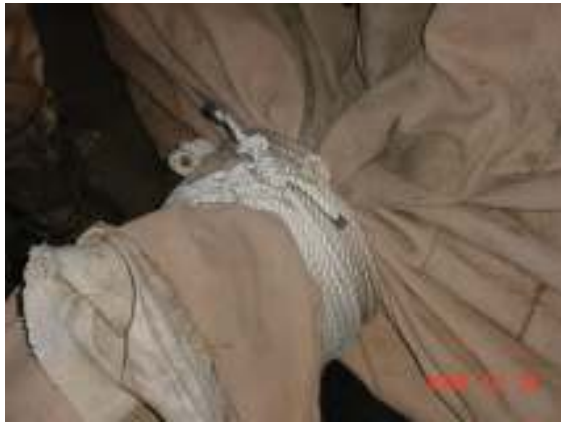
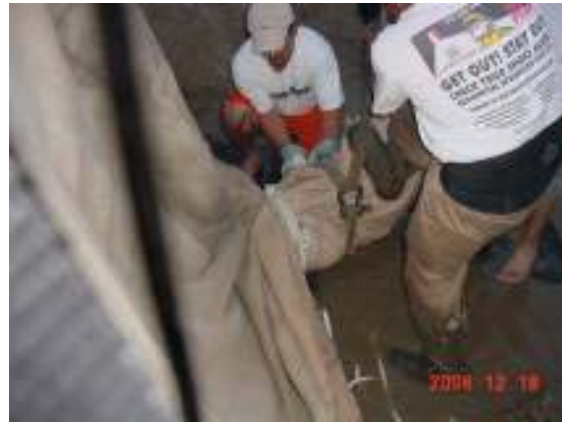
Groin Field Repairs – Geotextile manufacturer representatives made a site visit to assess the current condition of the damaged groins, make recommendations on how to further protect what

has not been damaged, look at what may be the cause of the groin tubes tearing/shredding at the ends and to try and stitch the ends shut. They were not overly optimistic as to what may be the cause of groins tearing other than time and the natural elements of UV rays breaking down the material along with the shell sediment being abrasive within the tidal zone. Unfortunately due to the geotextile material hardening over time the sewing machine would not pass the needle through the material and left us with no other option but to tie the ends shut. The manufacturer has taken some of the material removed back to Florida and will work to test various applications and provide a recommendation on what to apply to the rest of the groins to protect them from shredding. Atlantic Marine & Diving personnel along with Public Works staff have completed repairs to #2, #3 and #13 this week. The seaward end of these groins were cut back to a point past the shredding fabric and tied off, sealed and covered. Next week we will repair #5, #7 and #12 where the outer layer has shredded leaving the inner lining exposed. Erik recommends cutting these back as the inner lining has no structural integrity and it will only be a matter of time before it shreds.
